College Apartments

28 and 30 Garden Lane
Niceville, FL

2020 Reserve Fund Study

Project: **College Courtyard Apartments & Raider Student Housing**
Niceville, Florida

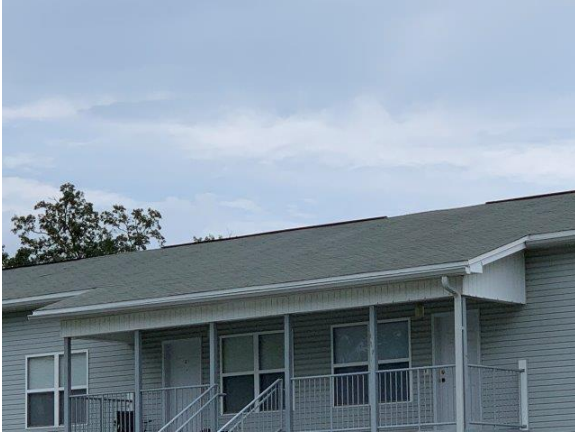
- A. RJH observed the **asphalt shingles** at both properties to be in fair condition. Reportedly the shingles are original to the building construction, and in RJH's professional opinion, are nearing the end of their serviceable life. No areas of shingle blow-off or shingle damage were observed however heavy granule lose was evident from observations. Granule loss indicates that the shingle is at or nearing the end of its serviceable life as the granules provide protection to the bitumen based portion of the shingle (Reference Photo Exhibit No. 6-18).

Photo Exhibit No. 7
Asphalt shingle roof on apartment building in fair condition.

- A. Based on the age and condition of the shingle roofing, RJH recommends considering replacement of the asphalt shingles in 2-5 years. The cash flow tables for both properties include replacement in year 2. Cost savings in efficiency are potentially available if both properties are completed at the same time. RJH recommends retaining a design professional such as a Professional Engineer or Registered Roof Consultant to provide drawings, details and specifications for the roof replacement project when it occurs.

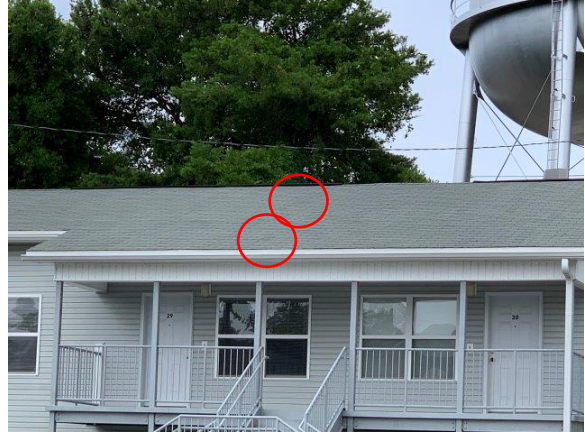
Photo Exhibit No. 10
Minor granule loss on asphalt shingles of apartment building.

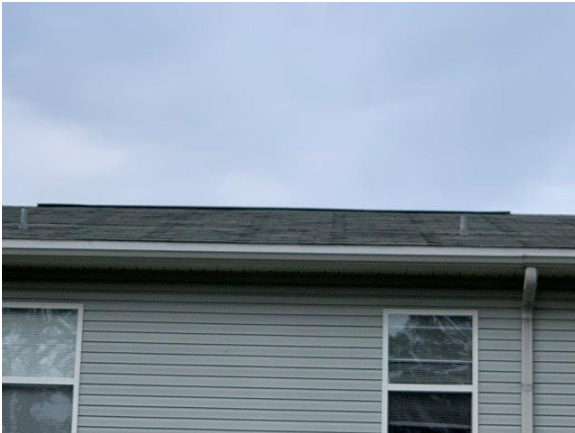
Photo Exhibit No. 8
Ridge venting of apartment building is in fair condition.

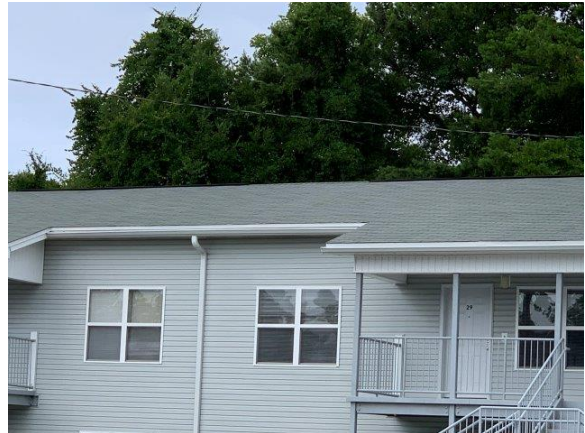
Photo Exhibit No. 11
Apartment roof shingles in fair condition.

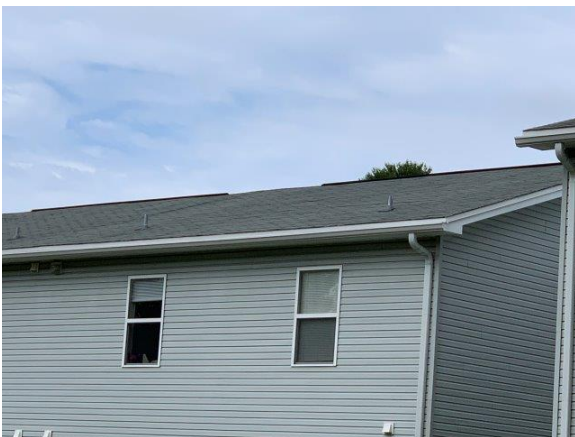
Photo Exhibit No. 9
Asphalt shingle roofing in fair condition at apartment building.

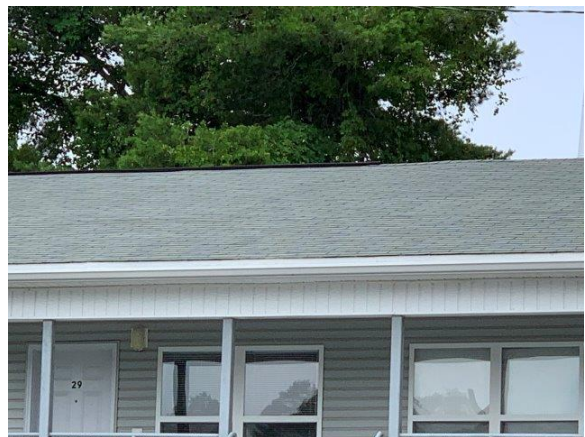
Photo Exhibit No. 12
Apartment ridge venting in fair condition.

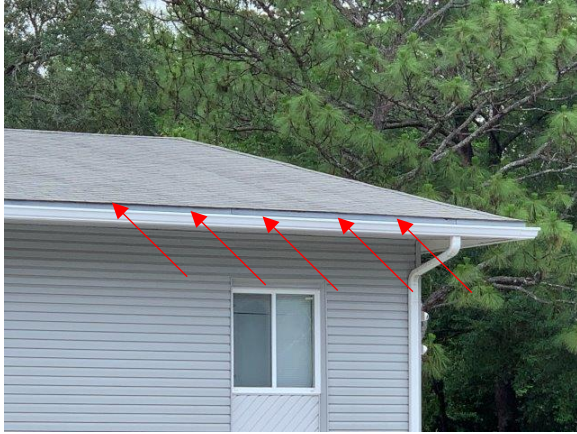
- B. On the student housing buildings, RJH observed the roof truss "lines" through the asphalt shingles. This typically indicates that the wood decking has settled/sagged over

time. While not an immediate concern this should be investigated further to ensure that the trusses have not failed on a structural level

Photo Exhibit No. 13
Truss lines visible through asphalt shingles at student housing.

- B. RJH recommends performing a roof truss condition assessment to verify the condition of the roof trusses and wood deck at the roof of all the student housing buildings.

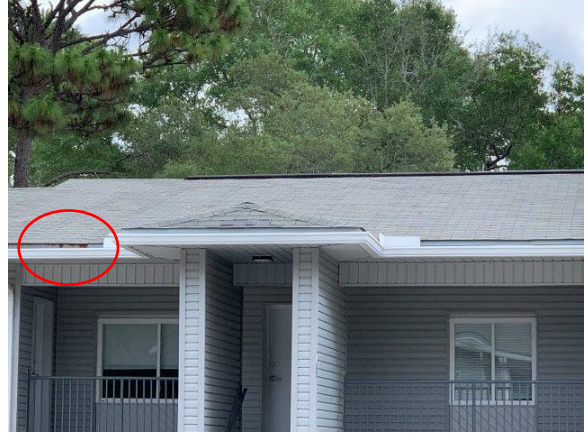
Photo Exhibit No. 16
Shingle deterioration and corrosion present on student housing roof.

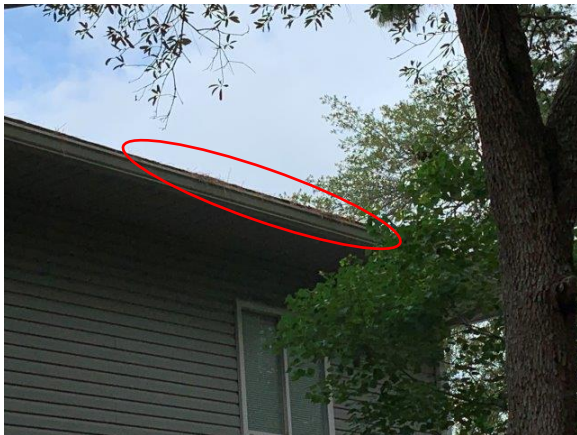
- C. RJH observed select locations where the gutter was observed to have sustained damage. The source of the damage is unknown.
- D. On the rear elevation of Building 4, RJH observed large amounts of debris in the gutter. There is a tree in very close proximity to the structure and leaves/twigs/branches that fall off of the tree have ended up in the gutter.

Photo Exhibit No. 14
Heavy buildup of debris in gutter on student housing building.

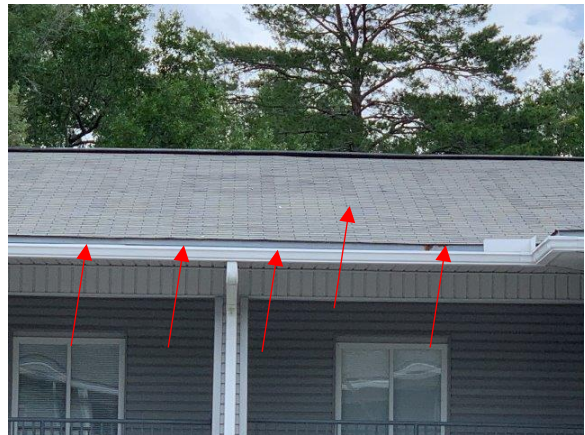
Photo Exhibit No. 17
Corrosion on metal components as well as truss lines visible through shingles.

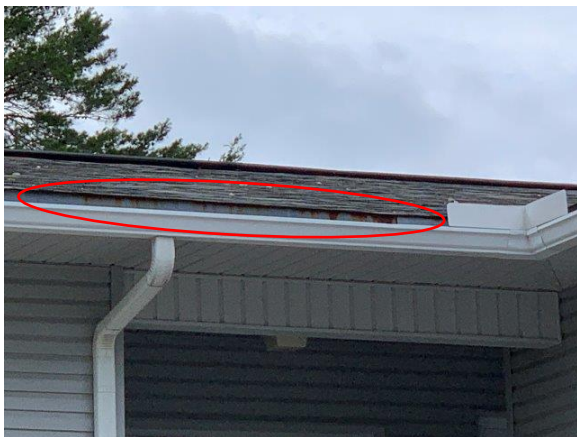
Photo Exhibit No. 15
Large amount of corrosion on shingle starter at student housing roof.

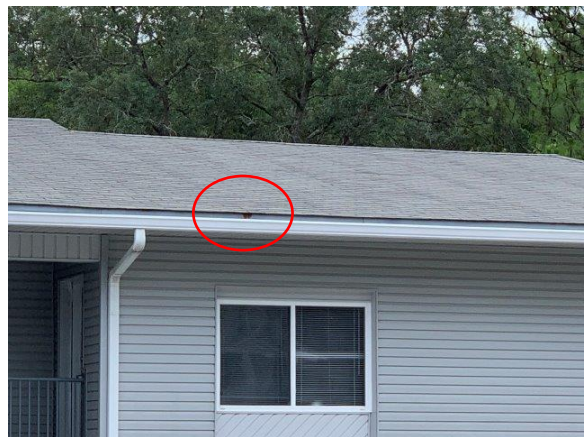
Photo Exhibit No. 18
Corrosion on metal roofing components on the student housing roof.

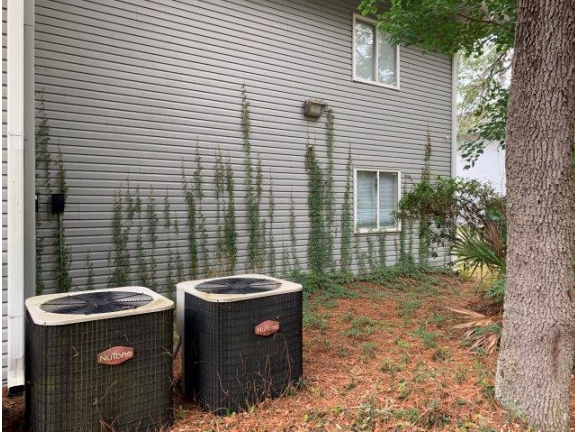
- H. Additionally, on building 4 of the student housing, RJH also observed creeping vines extending from the ground, up the side of the north elevation. This type of growth is detrimental to the siding and will pre-maturely cause failure. Staining and weathering was also observed throughout the siding that has been installed.

Photo Exhibit No. 19
Vegetation is growing up the side of this student housing building.

- C. Based on our observations, RJH recommends replacing the siding within 10 years. Due to the lack of weather resistant barrier, there could be concealed issues that will not be apparent until the siding is removed. Based on the age of the siding RJH recommends repairing the areas where damage was observed in the near future (0-1 year). These repairs are necessary in order for the siding to maintain its performance on the exterior of the building. Consideration may be given to performing core cuts to determine the existence of the weather resistant barrier beneath the siding.

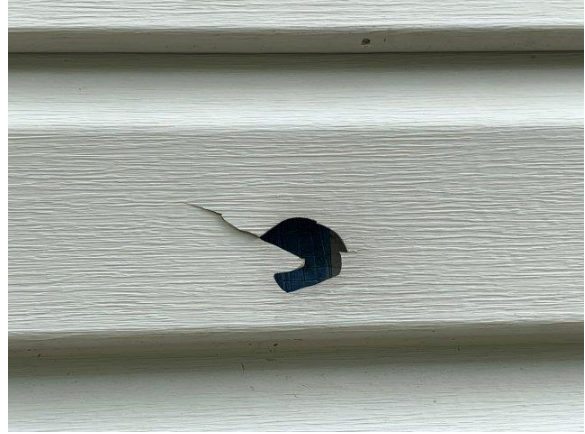
- I. Also observed at the siding was a lack of weather resistant barrier behind the siding. At various damaged locations it was observed that there was no “house wrap” such as Tyvek or weather resistant barrier. It is unknown whether this is an isolated issue or a systemic issue.

Photo Exhibit No. 22
Large hole in siding, no WRB visible beneath.

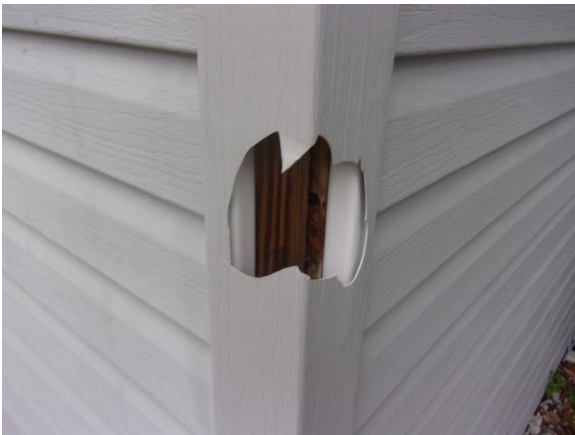
Photo Exhibit No. 20
Wood sheathing is visible beneath siding. No WRB present.

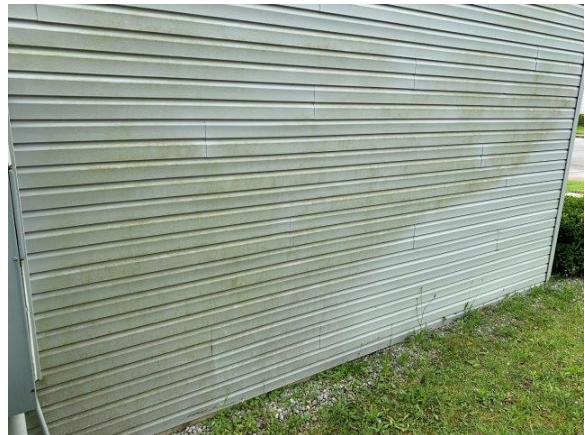
- F. The **siding** was also observed to be in fair condition. RJH observed a high number of cracks in the vinyl siding at both the student housing and the apartment units. Cracks and/or damage lead to water infiltration, which in turn can contribute to failure of other building components (Reference Photo Exhibit No. 19-24).

Photo Exhibit No. 23
Large area of staining on siding.

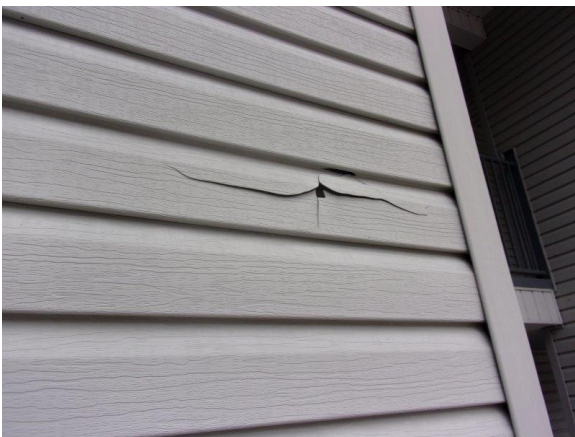
Photo Exhibit No. 21
Large crack in siding.

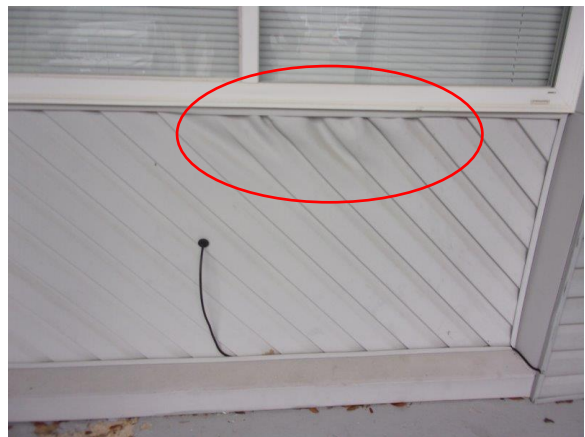
Photo Exhibit No. 24
Siding beneath this window was poorly installed.

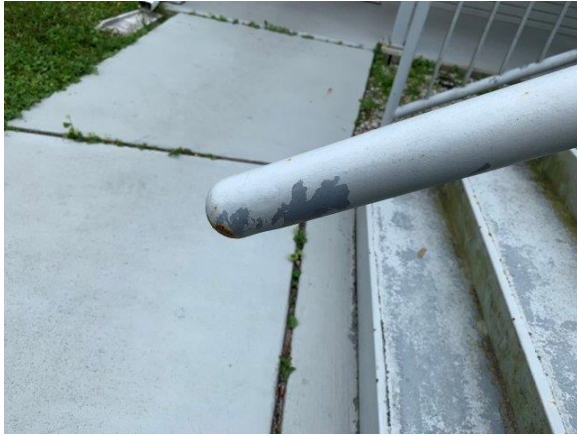
- J. RJH observed various components that require **exterior painting**, most notably the exterior stairs on the front of each building. It is expected that costs will be incurred annually or bi-annually for painting touch ups and/or paint restoration (Reference Photo Exhibit No. 25-30).

Photo Exhibit No. 25
Coating on railing needs to be touched up.

- D. RJH recommends performing touch ups as required for the painting. Allowances annually have been included in the cash flow tables for touch-ups to the metal railing and other components that may require painting in the future.

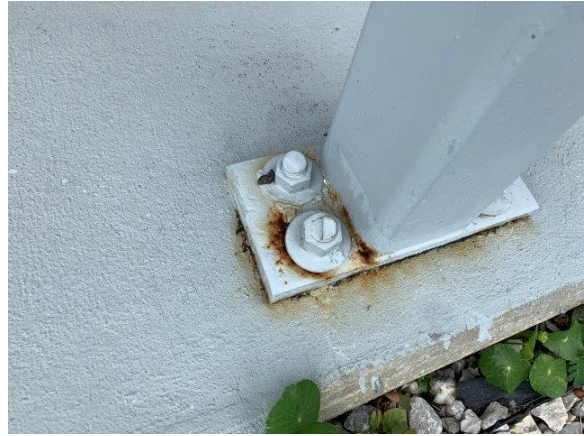
Photo Exhibit No. 28
Corrosion and minor paint failure on metal landing post.

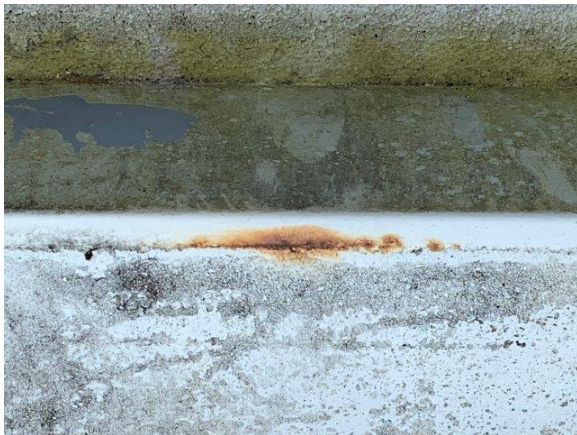
Photo Exhibit No. 26
Corrosion on metal stair component should be touched up.

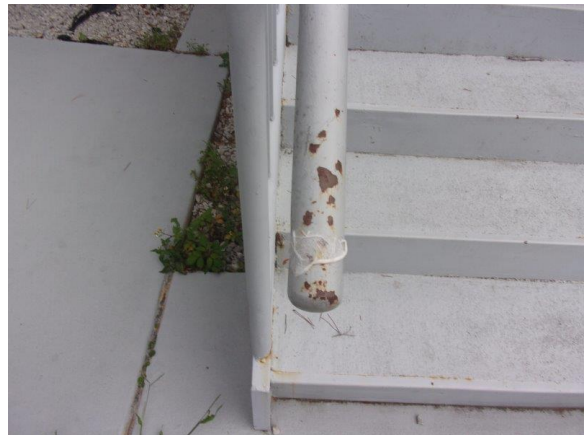
- L. At the rental property, RJH observed large areas of chipped or damaged coating that has been applied to the metal railing components. As mentioned above, exterior coating work on metal components such as these can be expected annually or every few years.

Photo Exhibit No. 29
Corrosion and paint failure on railing.

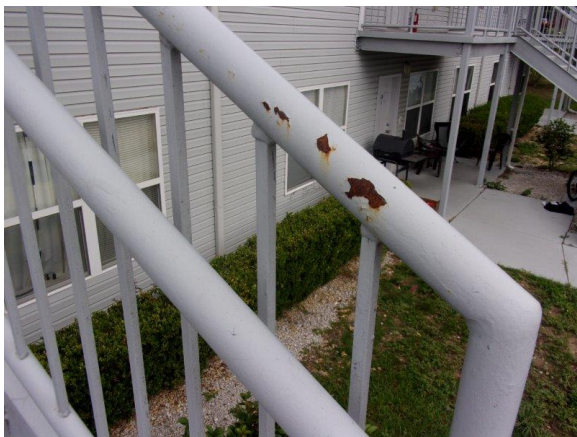
Photo Exhibit No. 27
Corrosion and paint failure on metal railing components.

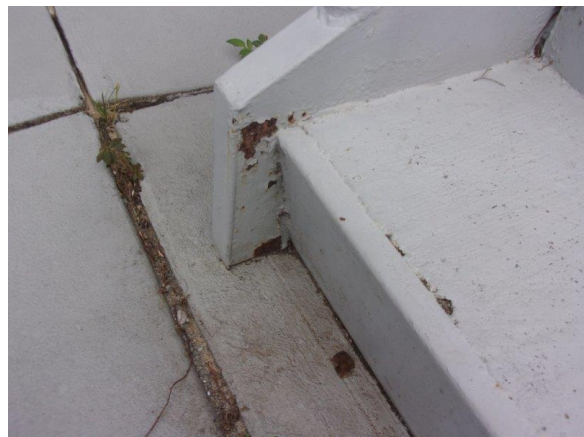
Photo Exhibit No. 30
Corrosion and coating failure on stair riser.

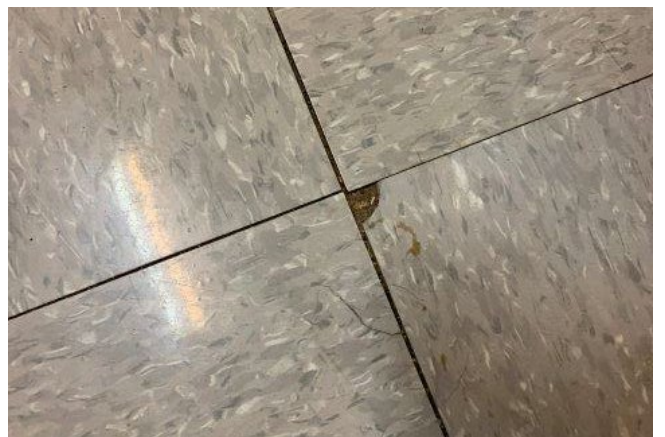
- C. RJH observed the **unit flooring** to be in fair condition. The flooring observed in all of the units was an adhered thin vinyl tile in the kitchen and carpet in the bedrooms. RJH observed minor damage to the flooring as well as various levels of gaps between the pieces of tiles. RJH was informed by maintenance personnel on site that the flooring is original to the construction. The Environmental Protection Agency and the Occupational Safety and Health Administration mandate that any substances that are to be worked on shall be surveyed prior to removal from any site. Typically flooring of this nature is applied using an adhesive. Sometimes the adhesive is an Asbestos-Containing Material (ACM). RJH recommends retaining an environmental consultant to perform testing of the material to confirm whether it is asbestos containing or not prior to its removal. RJH did not perform testing nor has any knowledge of the materials currently installed (Reference Photo Exhibit No. 40, 41 and 42).

Photo Exhibit No. 42
Damage at tile in kitchen.

- D. The costs in the cash flow tables do not account for any type of asbestos abatement and assume that the tiles are replaced with like in kind. Consideration may be given to installing a more durable, plank style, flooring.

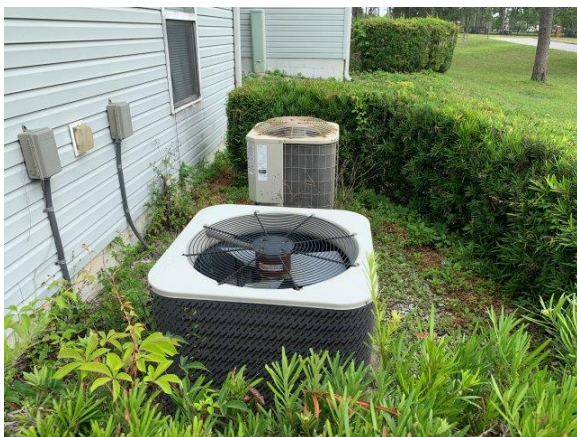
- B. Minor surface corrosion was observed on the unit housing, but no reports of any current issues were forwarded to RJH. One conduit appeared to be disconnected, however no reports of any issues were forwarded to RJH. Typically for a property this size, a mechanical contractor has a maintenance contract in effect. Varying brands of these units were observed. RJH has assumed a useful life of 9-10 years for these mechanical units.

Photo Exhibit No. 45
Exterior units appear to be in good condition, minor housing corrosion observed.

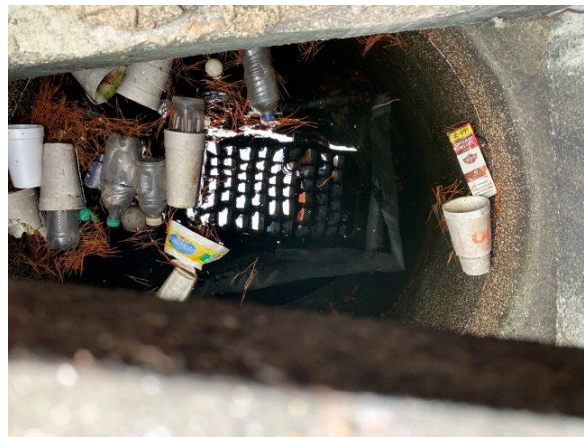
- D. RJH also observed large cracking extending the length of the parking lot in front of the student housing.
- E. RJH observed the storm water catch basins to be filled with debris. This can contribute to overland flooding if the storm sewers cannot drain properly and should be addressed.

Photo Exhibit No. 54
Large amount of debris in catch basin.

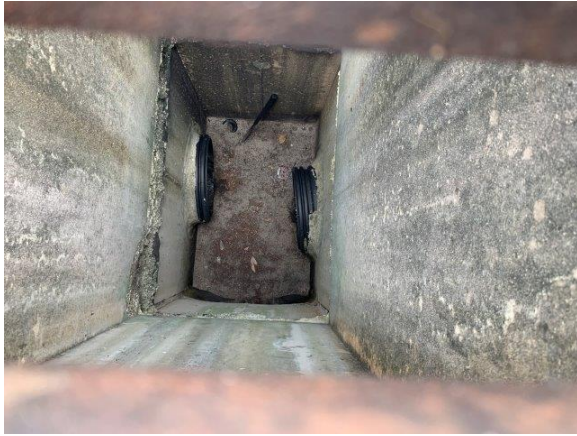
Photo Exhibit No. 55
Large amount of sand in catch basin.

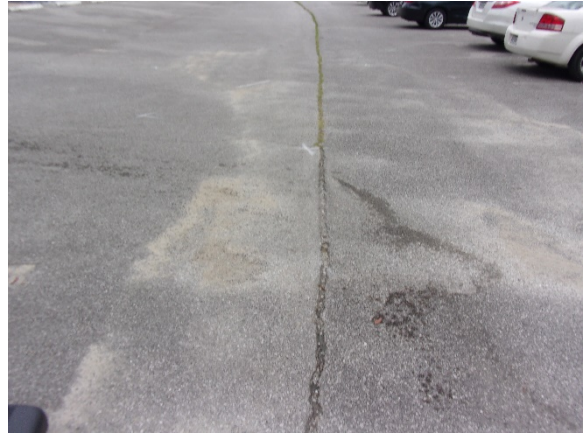
Photo Exhibit No. 58
Large crack runs entire length of parking lot in front of student housing.

- A. Based on our visual observations and the existing conditions of the asphalt pavement RJH believes there is 0-2 years of estimated life remaining before undertaking an asphalt restoration project. Because of the rutting and settlement observed, RJH has not included allowances for base repairs to the base material. RJH also recommends retaining a Professional Engineer specializing in asphalt to design, specify and provide technical drawings for the new asphalt when the time comes for replacement/restoration.

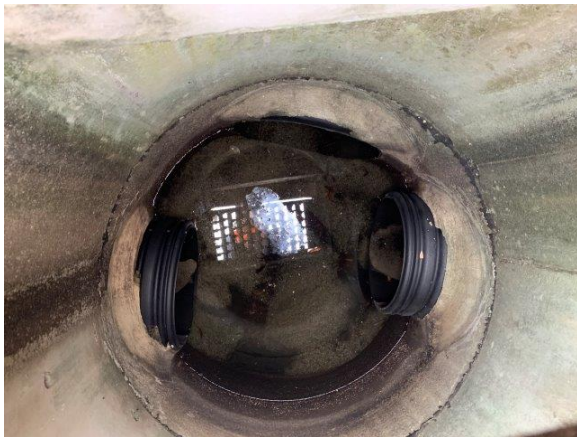
Photo Exhibit No. 56
Large amount of sand in catch basin and visible within pipe as well.

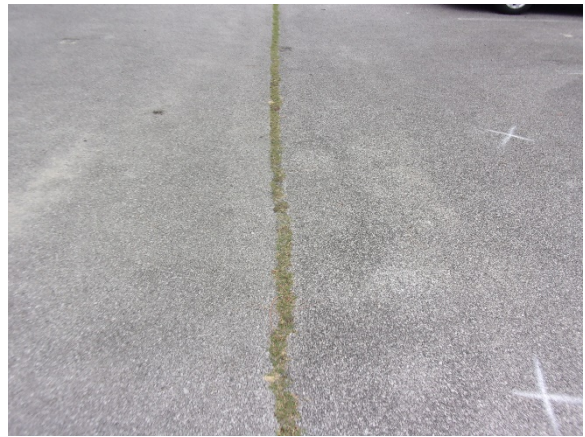
Photo Exhibit No. 59
Large crack runs entire length of parking lot in front of student housing.

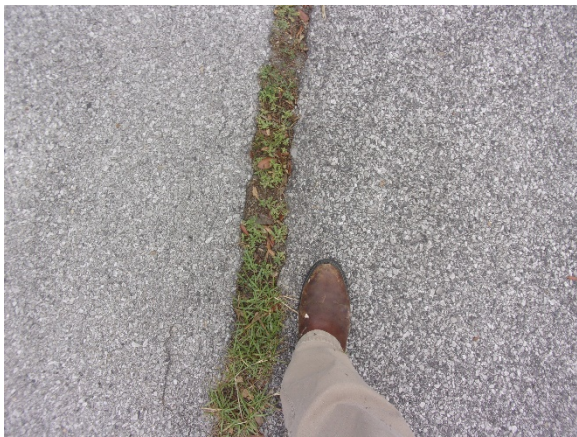
Photo Exhibit No. 57
Large cracking in asphalt that has become overgrown.

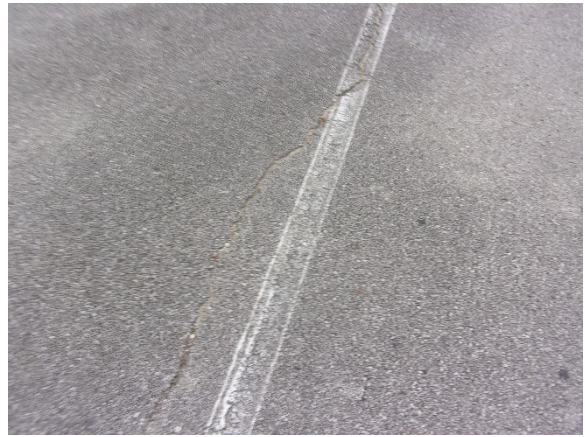
Photo Exhibit No. 60
Large crack extending from perimeter into field of parking lot.

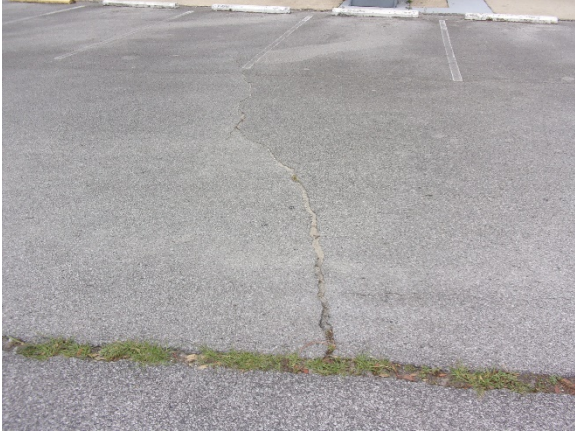
Photo Exhibit No. 61
Large crack extending length of parking lot.

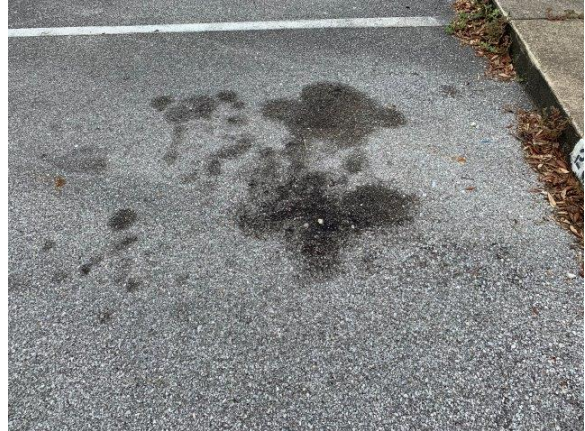
- C. While not an immediate concern, loss of fines can contribute to accelerated failure of the asphalt as a whole. Vehicle oil, spills and leaks can contribute to pre-mature failure and accelerated degradation of asphalt bitumen.

Photo Exhibit No. 64
Vehicle oils/liquids cause pre-mature failure of asphalt bitumen.

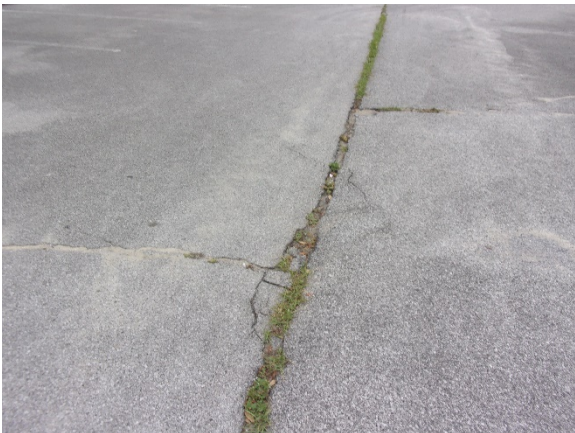
Photo Exhibit No. 62
Large crack runs entire length of parking lot Infront of student housing.

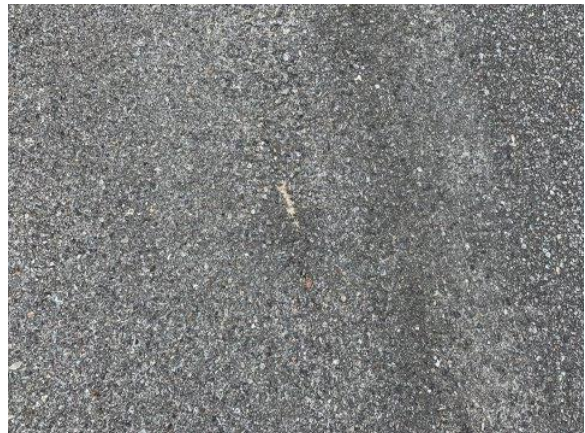
Photo Exhibit No. 65
Loss of fines and exposed aggregate.

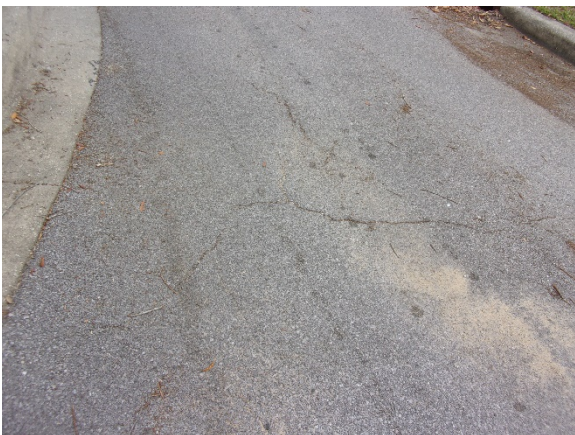
Photo Exhibit No. 63
Alligator cracking within main drive lane.

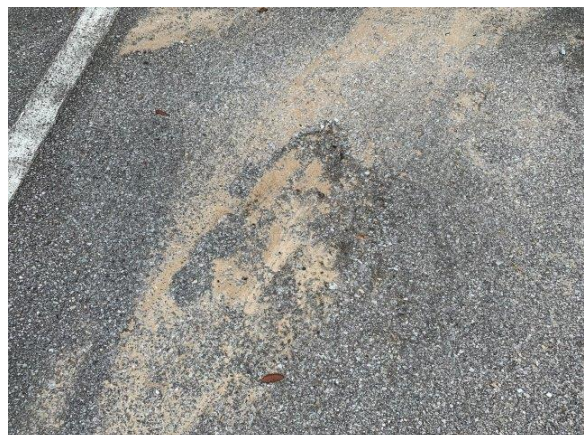
Photo Exhibit No. 66
Loss of fines and exposed aggregate.
